NASA TN D-1376

INFLUENCE OF TIRE TREAD PATTERN AND RUNWAY SURFACE

CONDITION ON BRAKING FRICTION AND ROLLING

RESISTANCE OF A MODERN AIRCRAFT TIRE

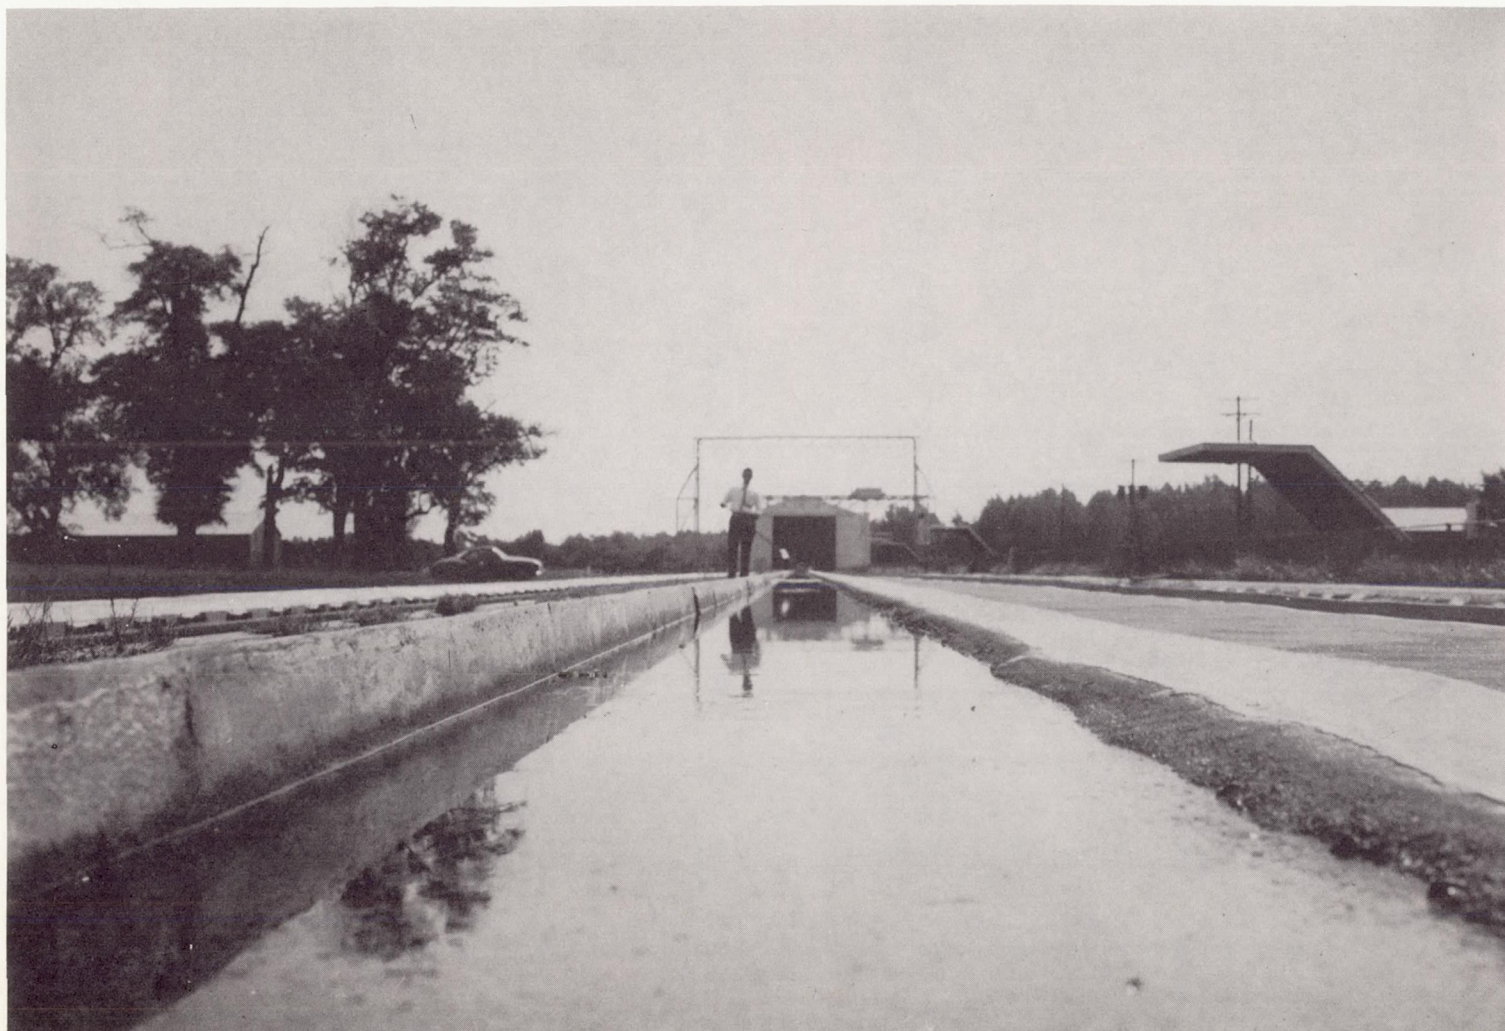
Figure 9.- Water-covered concrete runway immediately before wheel-braking run. L-62-2076
 $d_1 = 0 \text{ to } 0.3 \text{ inch.}$

The elevation characteristics of the concrete runway within the confines of the trough shown in figure 7 were such that with just the high spots of the runway showing through the water surface, the water depth in the trough varied between 0 and 0.3 inch. This degree of wetness corresponds to conditions measured on an actual runway during a heavy rain shower. Figure 9 is a photograph of the concrete runway for this condition of wetness.

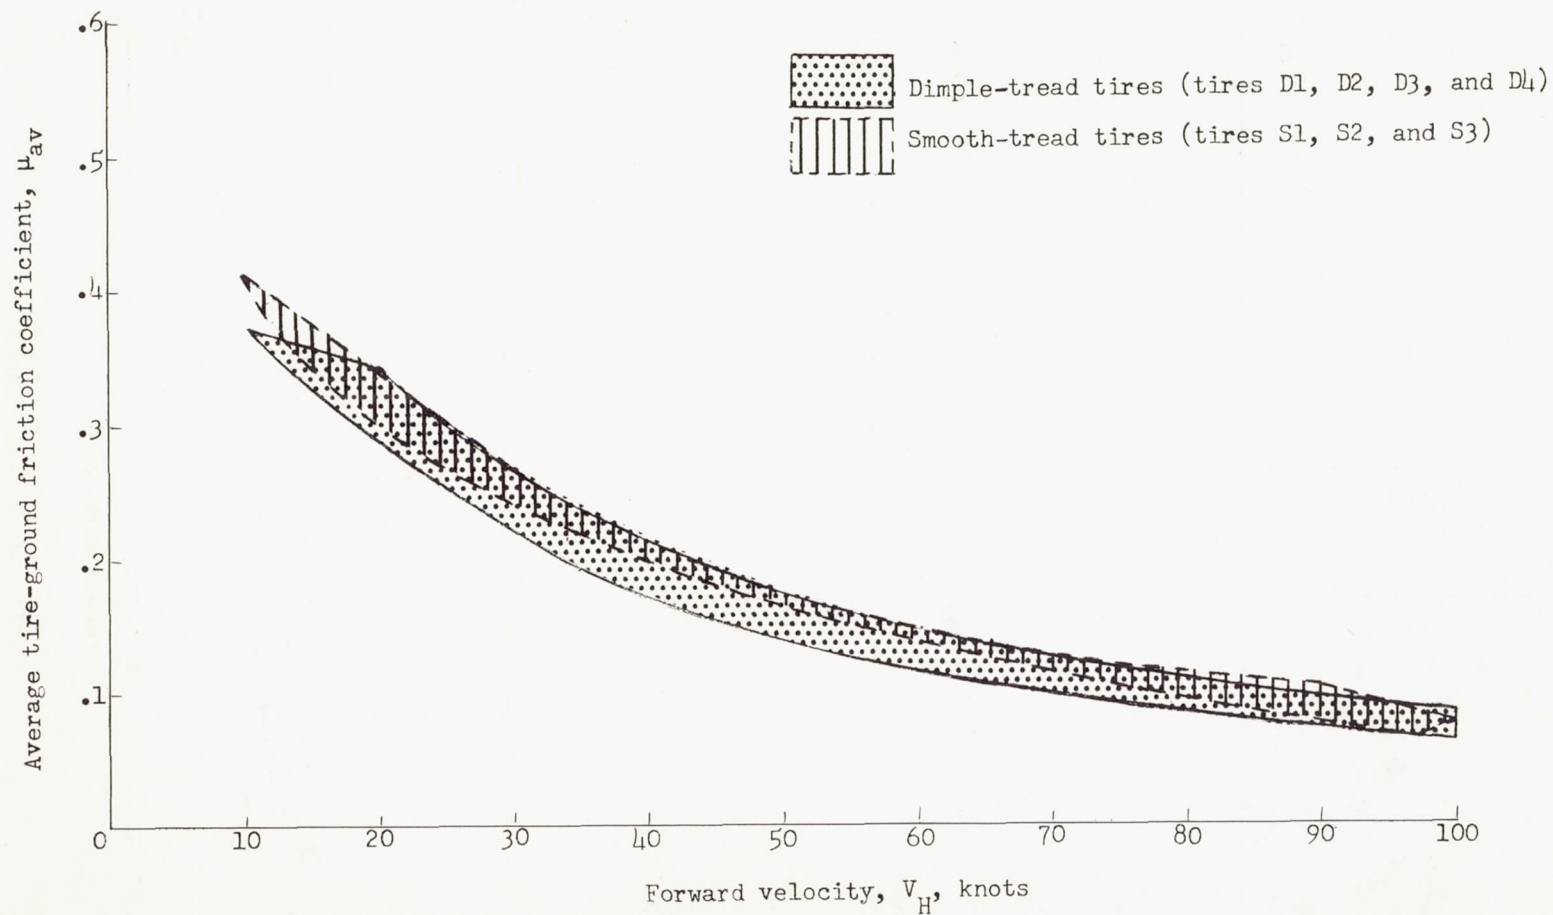
Figure 47.- Average tire-ground friction coefficients obtained with smooth- and dimple-tread tires during braking tests on a water-covered concrete runway. $F_{z,g} \approx 10,000$ pounds; $p = 260$ lb/sq in.; $d_1 = 0$ to 0.3 inch.
